TREE INVENTORY

EIGHT-YEAR MANAGEMENT PLAN

Arbor Ridge Cottage Collection

August, 2012

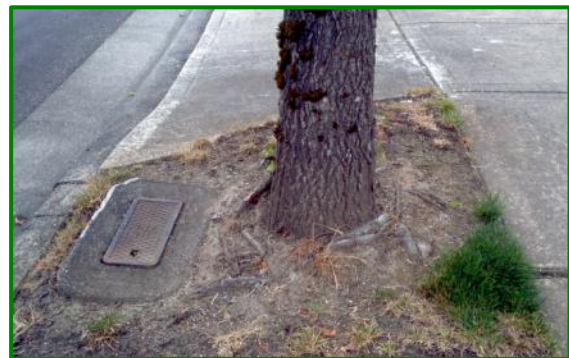
Tree is planted on water main line.

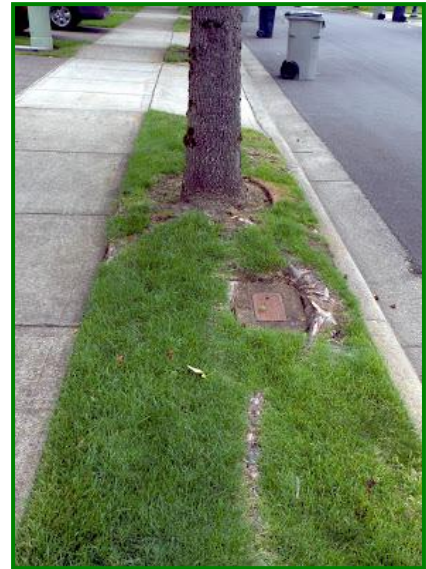
Tree roots extend beyond 6'.

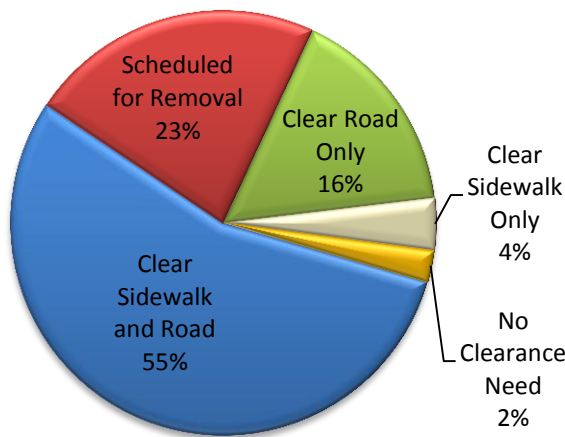
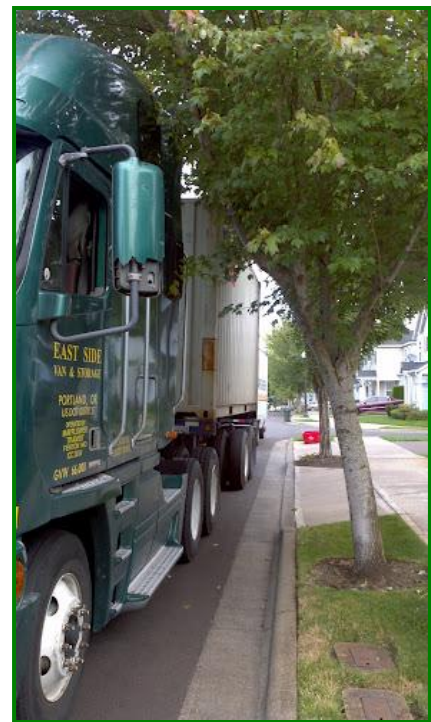
Branches over the road require this truck to park far from the curb. Clearance of 14' is recommended.

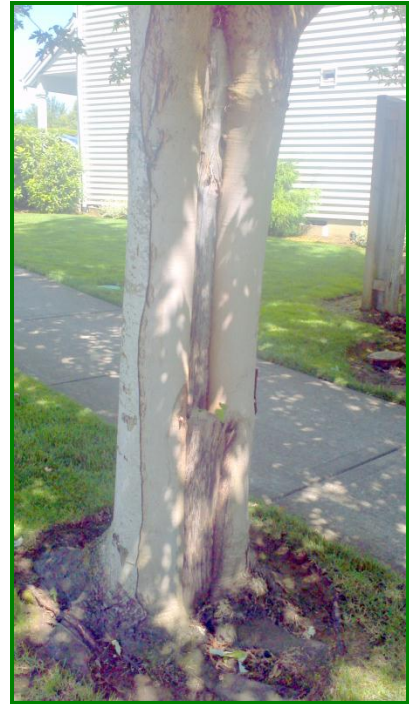
Only one (1) of the 333 trees was recommended for urgent maintenance. This tree had significant trunk damage that caused it to be structurally unsound and the condition of the tree is critical. The remaining trees require routine pruning or removal as budgets allow.

One tree was recommended for urgent maintenance because of a trunk wound that compromises its structural integrity.

Remove seventy-four (74) trees located within 0-2' of critical infrastructure and one (1) tree determined to be in critical condition due to a large trunk wound. Plant ten (10) trees in vacant sites.

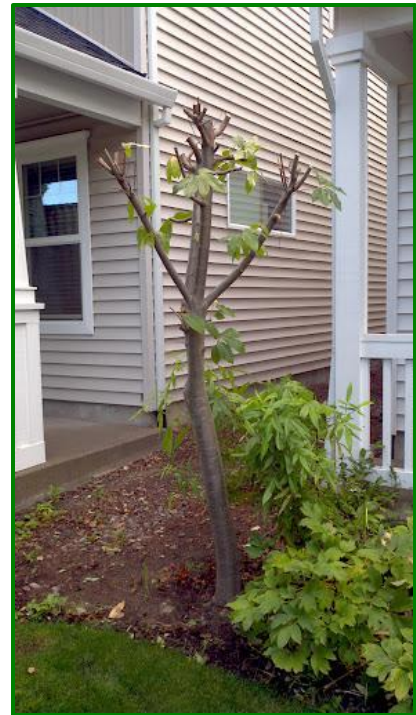
A young tree is incorrectly pruned.

General landscape contractors should be engaged to remove stakes after planting and maintain mulch around trees. Unless properly trained, they should not be allowed to prune any trees, including young trees, because poor pruning cuts can devalue newly planted street trees or cause structural defects that are costly to correct and reduce the useful lifespan of the tree. Topping, rounding-over, and failure to correct co-dominant stems are common mistakes made by those untrained in the care of landscape trees, but qualified tree workers are trained to avoid these mistakes, shaping young trees to become valuable assets to the neighborhood that require less pruning and maintenance as they mature.
