Arbor Ridge P.U.D. Homeowners Association - Master
Northwest Laidlaw Road & Northwest 174th Avenue
Bethany, Oregon 97006
Account 1215a - Version 1.01

Fiscal Year: January 1, 2020 to December 31, 2020

OFF-SITE RESERVE STUDY & MAINTENANCE PLAN

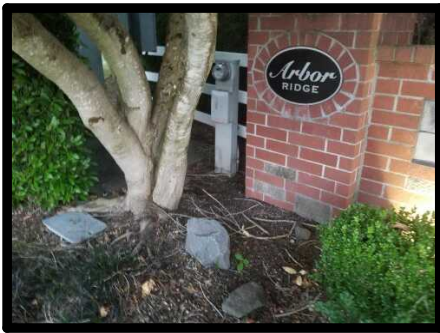
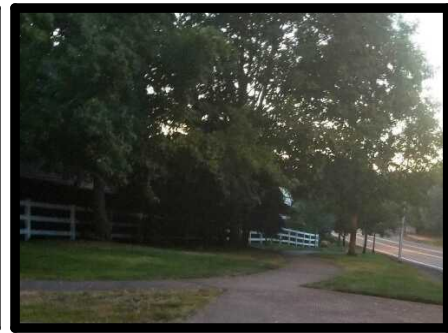
Arborist / Tree Work

We have increased the component base cost for inflation. We have subtracted one year from the remaining useful life as presented 2019 on-site reserve study.

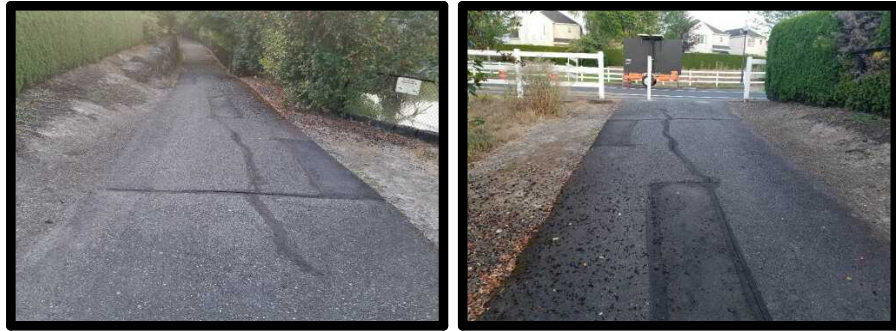
We have increased the component base cost for inflation. We have extended the overlay to the year 2030 in order to align with the 2030 seal coat. This is a constantly moving target and should be reevaluated in the scope of future reserve studies.
