Arbor Ridge P.U.D. Homeowners Association - Master
Northwest Laidlaw Road & Northwest 174th Avenue
Bethany, Oregon 97006
Account 1215a - Version 1.01

Fiscal Year: January 1, 2020 to December 31, 2020

OFF-SITE RESERVE STUDY & MAINTENANCE PLAN

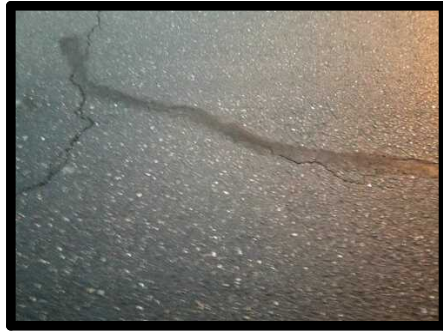
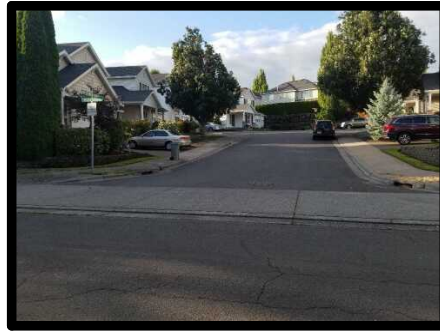
Asphalt: Overlay - Silver Creek Place

We have increased the component base cost for inflation. We have extended the overlay to the year 2035 in order to align with the 2035 seal coat. This is a constantly moving target and should be reevaluated in the scope of future reserve studies.

No deficiencies have been reported to our office about this component. Proper ongoing maintenance will likely extend the lifespan of this component in accordance with manufacturer's specifications.

Asset condition: Good to fair. This constantly requires monitoring for safety reasons.

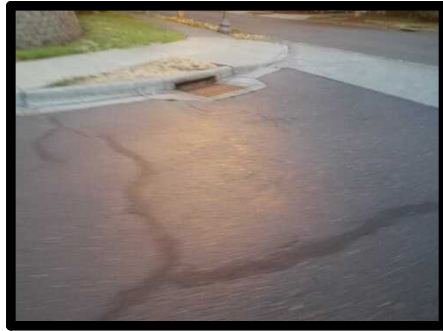
Asphalt: Repairs - Silver Creek Place

This line item is for the maintenance of the asphalt overlay in the driving areas of the community during each seal coat cycle. Overlay surface appeared in fair condition and should be seal coated every 3-5 years in order to maximize life expectancy. The existing seal coat appears to have been completely diminished and should be reapplied.

No deficiencies have been reported to our office about this component. Proper ongoing maintenance will likely extend the lifespan of this component in accordance with manufacturer's specifications.

Asset condition: Good to fair. This constantly requires monitoring for safety reasons.

ReserveStudyUpdate.com, LLC strongly recommends that the Board obtain at least two or three estimates and/or competitive bids to affirm this estimate. As with any component listed in any of our reserve studies, should the Board and/or management find that these cost projections need to be revised, ReserveStudyUpdate.com, LLC is more than happy to make these changes to the electronic file (PDF) and provide the updated report completely free of charge prior to or during the fiscal year that the study is prepared for. This measure will aid in maintaining proper reserve funding equilibrium and aid in proper contribution to reserves.

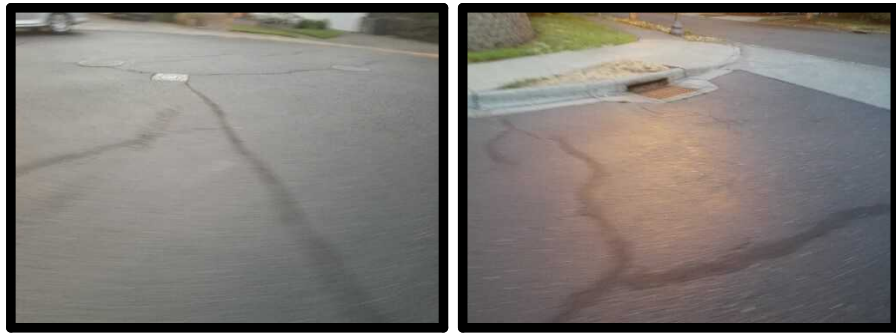
Asphalt: Sealcoat - Silver Creek Place

This line item is a provision to replace the asphalt seal coat on a 4-5 year cycle on the private roadway. Life expectancy of overlay will vary depending how the Board of Directors strategize the maintenance for this line item including but not limited to seal coating at regular intervals.

No deficiencies have been reported to our office about this component. Proper ongoing maintenance will likely extend the lifespan of this component in accordance with manufacturer's specifications.

Asset condition: Good to fair. This constantly requires monitoring for safety reasons.

The Board should obtain a bid to confirm this estimate as the cost varies due to accessibility and other related factors. This line item should coincide with overlay repair cycle as this has been separated in a different line item in this reserve study report.

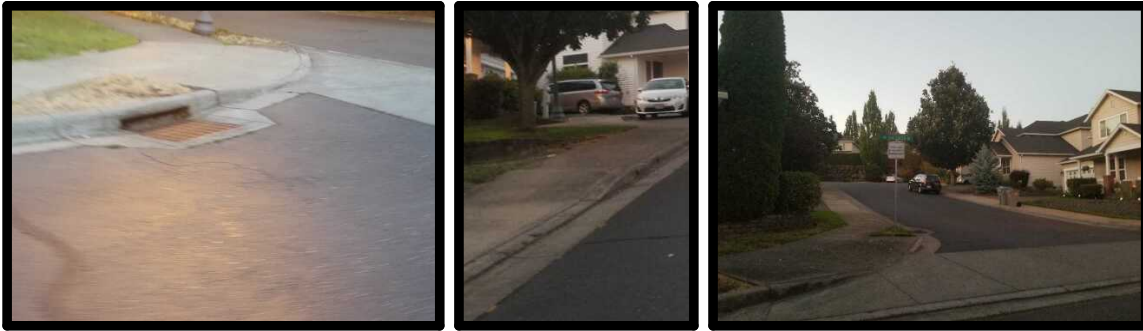
Concrete: Flatwork - Sidewalks - Silver Creek Place

No deficiencies have been reported to our office about this component. Proper ongoing maintenance will likely extend the lifespan of this component in accordance with manufacturer's specifications. We have extended the life of these components based on the present visual condition.

Asset condition: Good to fair. This constantly requires monitoring for safety reasons.

ReserveStudyUpdate.com, LLC strongly recommends that the Board obtain at least two or three estimates and/or competitive bids to affirm this estimate. As with any component listed in any of our reserve studies, should the

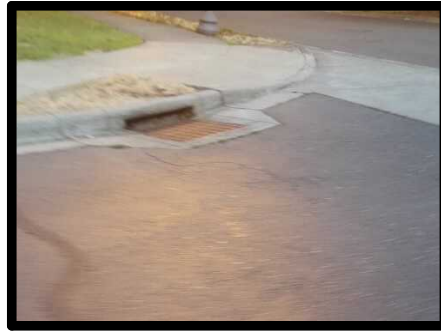
Storm Drains / Underground Inspection: Silver Creek Place

We have increased the component base cost for inflation. We have subtracted one year from the remaining useful life as presented 2019 on-site reserve study.

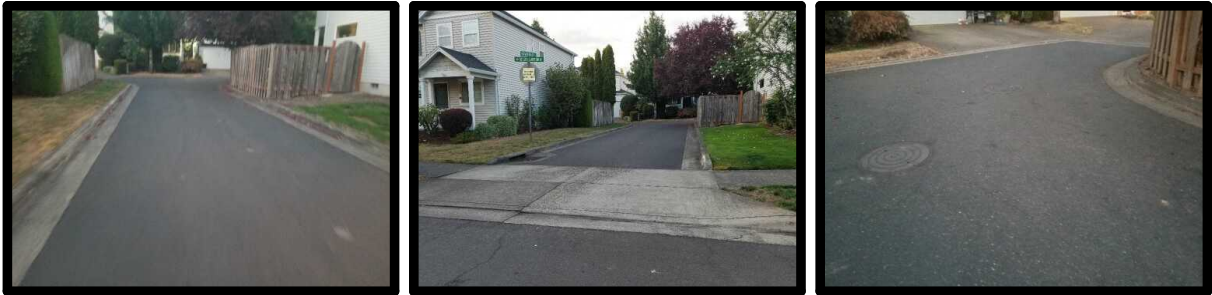
Asphalt: Overlay - Tatum Ranch Place

We have increased the component base cost for inflation. We have extended the overlay to the year 2035 in order to align with the 2035 seal coat. This is a constantly moving target and should be reevaluated in the scope of future reserve studies.

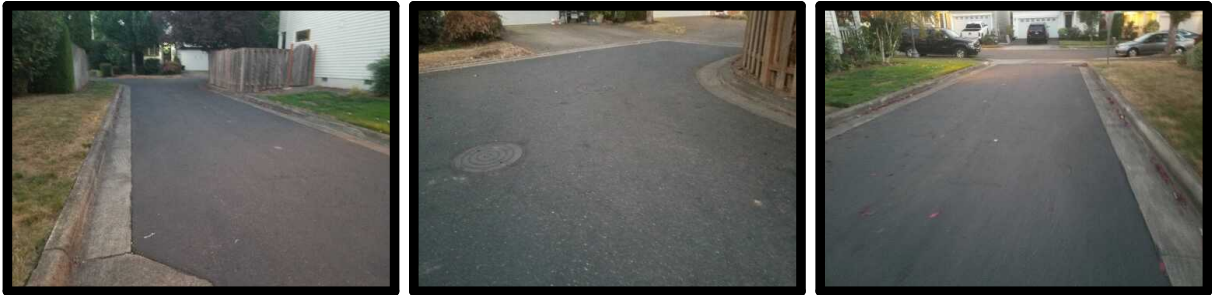
Asphalt: Repairs - Tatum Ranch Place

We have increased the component base cost for inflation. We have subtracted one year from the remaining useful life as presented 2019 on-site reserve study.

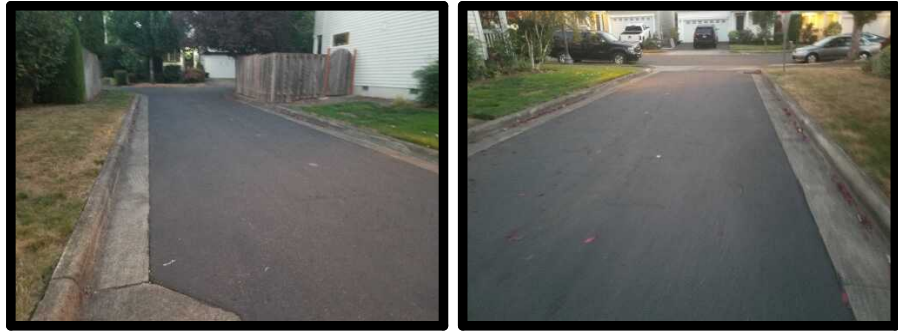
Asphalt: Sealcoat - Tatum Ranch Place

We have increased the component base cost for inflation. We have subtracted one year from the remaining useful life as presented 2019 on-site reserve study.

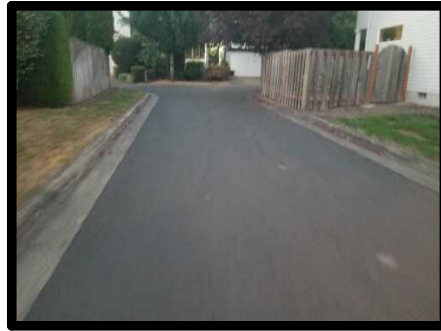
Concrete: Curbs & Gutters: Tatum Ranch Place

We have increased the component base cost for inflation. We have subtracted one year from the remaining useful life as presented 2019 on-site reserve study.

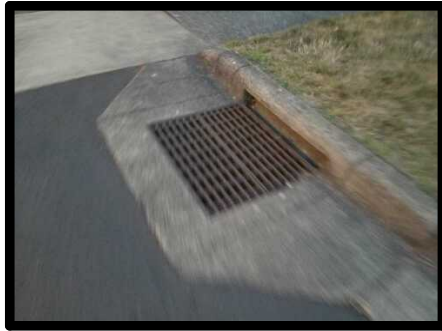
Storm Drains / Underground Inspection: Tatum Ranch Place

We have increased the component base cost for inflation. We have subtracted one year from the remaining useful life as presented 2019 on-site reserve study.
