# Reserve Funding

## **Arbor Ridge P.U.D. Homeowners Association-Master**

NW Laidlaw Road & NW 174th Avenue  
Beaverton, Oregon 97006  
July 21, 2014

### **Executive Summary**

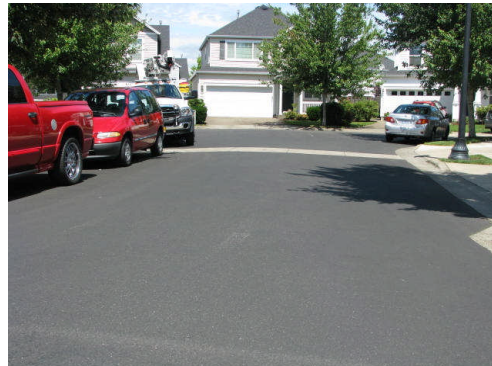
<b>Asphalt: Overlay-Moon Valley</b>		4,750 SF	@ \$1.20
Asset ID	1012	Asset Cost	\$5,700.00
Group	Capital	Percent Replacement	100%
Category	Asphalt	Future Cost	\$7,547.29
Placed in Service	January 2001		
Useful Life	30		
Replacement Year	2031		
Remaining Life	16

This item is the overlay of the asphalt street serving 6 lots per the Declaration called Moon Valley Terrace.

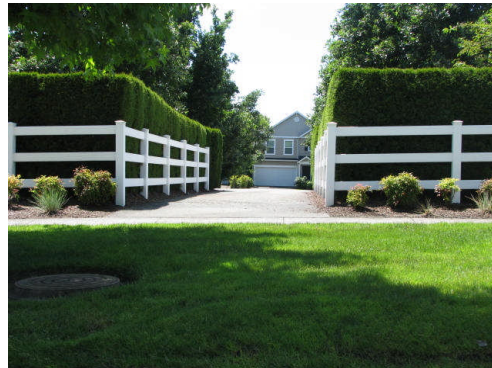
4,510 SF	@ \$1.20
Asset ID	1001	Asset Cost	\$5,412.00
Group	Capital	Percent Replacement	100%
Category	Asphalt	Future Cost	\$7,165.96
Placed in Service	January 2001		
Useful Life	30		
Replacement Year	2031		
Remaining Life	16

This item is the overlay of the asphalt pathway for the master association.

Funds may be used to repair the asphalt failure if needed (see Asphalt-S/C-Path.).

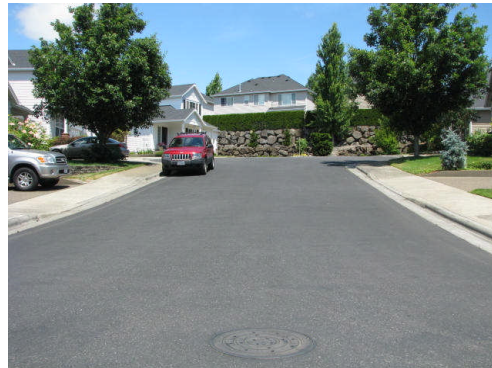
<b>Asphalt: Overlay-Silver Creek</b>		5,125 SF	@ \$1.20
Asset ID	1014	Asset Cost	\$6,150.00
Group	Capital	Percent Replacement	100%
Category	Asphalt	Future Cost	\$8,143.13
Placed in Service	January 2001		
Useful Life	30		
Replacement Year	2031		
Remaining Life	16

This item is the overlay of the asphalt street serving 7 lots called Silver Creek Place.

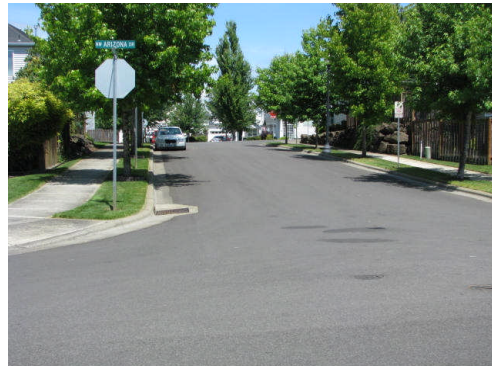
<b>Asphalt: Overlay-Tatum Ranch</b>		1,391 SF	@ \$1.20
Asset ID	1016	Asset Cost	\$1,669.20
Group	Capital	Percent Replacement	100%
Category	Asphalt	Future Cost	\$2,210.16
Placed in Service	January 2001		
Useful Life	30		
Replacement Year	2031		
Remaining Life	16

This item is the overlay of the asphalt street serving 3 lots called Tatum Ranch Place.

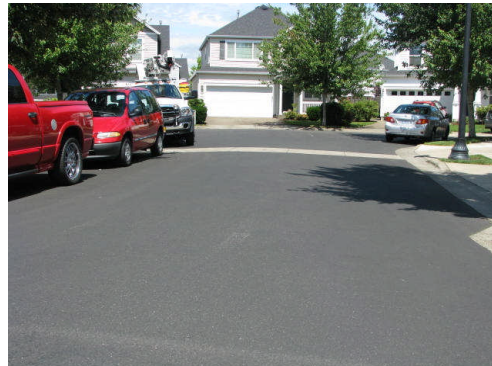
<b>Asphalt: Repairs-Moon Valley</b>		4,750 SF	@ \$3.75
Asset ID	1027	Asset Cost	\$536.16
Group	Capital	Percent Replacement	3.01%
Category	Asphalt	Future Cost	\$575.14
Placed in Service	July 2014		
Useful Life	5		
Replacement Year	2019		
Remaining Life	4

This item is the repairs required on the private street.

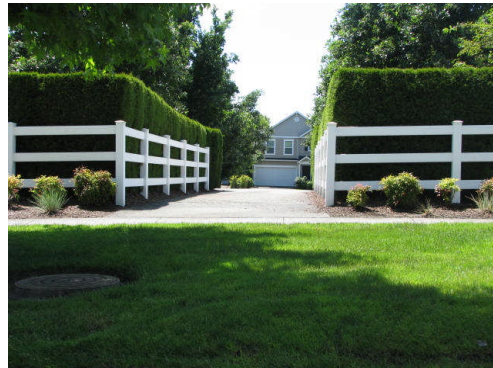
**Asphalt: Repairs-Path**

This item is the repairs required on the pathway.

The asphalt has numerous cracks and subsidence at the present time.

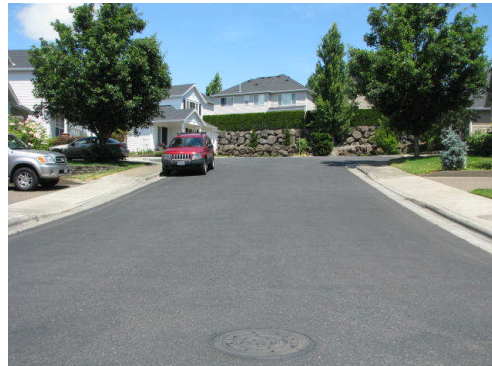
<b>Asphalt: Repairs-Silver Creek</b>		5,390 SF	@ \$3.75
Asset ID	1032	Asset Cost	\$828.71
Group	Non-Capital	Percent Replacement	4.1%
Category	Asphalt	Future Cost	\$888.96
Placed in Service	January 2014		
Useful Life	5		
Replacement Year	2019		
Remaining Life	4

This item is the repairs required on the private street.

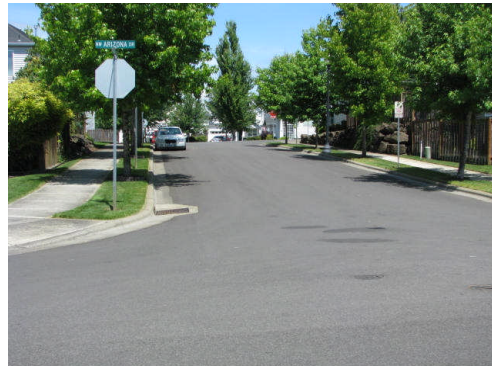
<b>Asphalt: Repairs-Tatum Ranch</b>		1,391 SF	@ \$3.75
Asset ID	1033	Asset Cost	\$185.18
Group	Capital	Percent Replacement	3.55%
Category	Asphalt	Future Cost	\$198.64
Placed in Service	July 2014		
Useful Life	5		
Replacement Year	2019		
Remaining Life	4

This item is the repairs required on the private street.

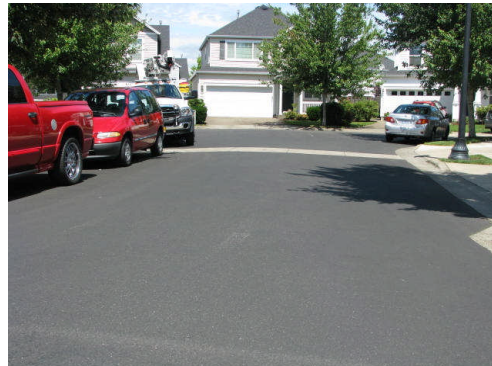
<b>Asphalt: Sealcoat-Moon Valley</b>		4,750 SF	@ \$0.14
Asset ID	1013	Asset Cost	\$665.00
Group	Non-Capital	Percent Replacement	100%
Category	Asphalt	Future Cost	\$700.94
Placed in Service	September 2013		
Useful Life	5		
Replacement Year	2018		
Remaining Life	3

This item is the seal coating, and re-striping of the asphalt street serving 6 lots called Moon Valley Terrace.

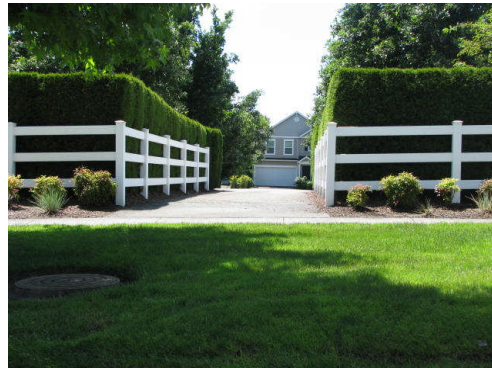
<b>Asphalt: Sealcoat-Path</b>		4,510 SF	@ \$0.16
Asset ID	1002	Asset Cost	\$721.60
Group	Non-Capital	Percent Replacement	100%
Category	Asphalt	Future Cost	\$760.60
Placed in Service	September 2013		
Useful Life	5		
Replacement Year	2018		
Remaining Life	3

This item is the resealing, and re-striping of the asphalt path for the master association.

The asphalt has numerous cracks and subsidence at the present time.

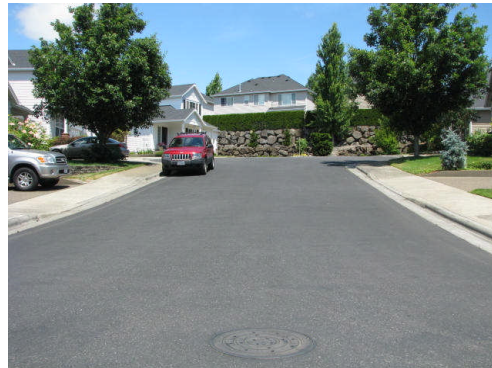
<b>Asphalt: Sealcoat-Silver Creek</b>		5,390 SF	@ \$0.14
Asset ID	1015	Asset Cost	\$754.60
Group	Non-Capital	Percent Replacement	100%
Category	Asphalt	Future Cost	\$795.38
Placed in Service	September 2013		
Useful Life	5		
Replacement Year	2018		
Remaining Life	3

This item is the sealcoating, and restriping of the asphalt street serving 7 lots called Silver Creek Place.

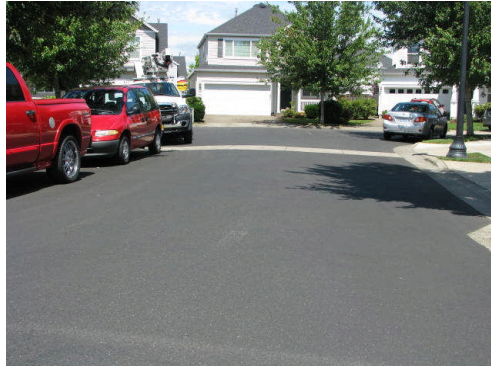
This item is the sealcoating, and re-striping of the asphalt street serving 3 lots called Tatum Ranch Place.

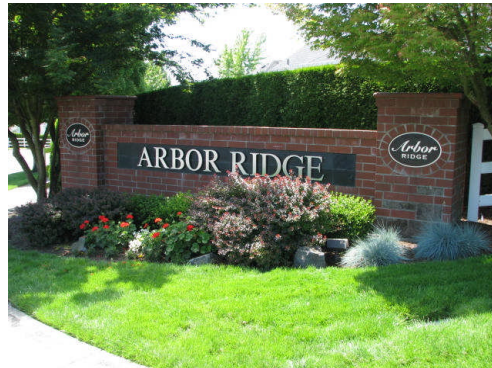
<b>Brick: Pilaster-Wall</b>		15 Each	@ \$450.00
Asset ID	1007	Asset Cost	\$6,750.00
Group	Capital	Percent Replacement	100%
Category	Masonry	Future Cost	\$8,937.58
Placed in Service	January 2001		
Useful Life	30		
Replacement Year	2031		
Remaining Life	16

This item is an allowance for any work required on the masonry pilasters and walls at the common area fencing and monument, which may have a life expectancy of more than 30 years. However, we have allowed for any repair, maintenance or replacement within the 30 years.

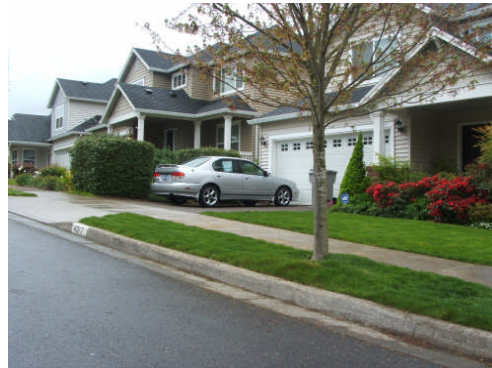
<b>Concrete: Flatwork-Sidewalks</b>		2,326 SF	@ \$12.00
Asset ID	1024	Asset Cost	\$5,582.40
Group	Capital	Percent Replacement	20%
Category	Concrete	Future Cost	\$5,582.40
Placed in Service	January 2001		
Useful Life	10		
Adjustment	4		
Replacement Year	2015		
Remaining Life	0

This item is 20% of the total concrete sidewalks in the common area, which may need repairs, maintenance or replacement within a 10-year period.

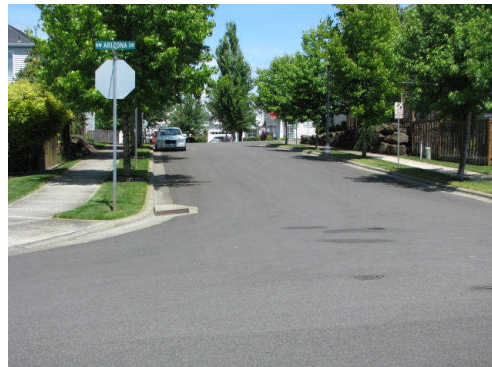
This item is the repair, maintenance or replacement of 20% of the concrete sidewalk by the private street Moon Terrace, which may need work within 10 years.

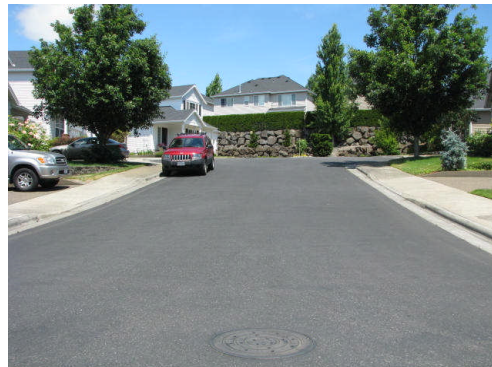
This item is the repair, maintenance or replacement of 20% of the concrete sidewalks on the private street Silver Creek, which may need work within 10 years.

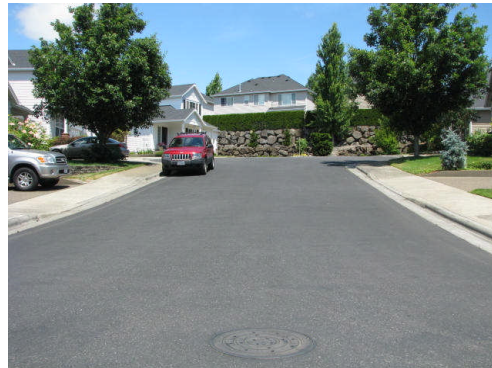
<b>Curb-Gutter: Moon Valley</b>		263 LF	@ \$8.00
Asset ID	1019	Asset Cost	\$2,104.00
Group	Capital	Percent Replacement	100%
Category	Concrete	Future Cost	\$2,104.00
Placed in Service	January 2001		
Useful Life	12		
Adjustment	2		
Replacement Year	2015		
Remaining Life	0

This item is the repair, maintenance or replacement of the concrete vertical curb and gutter on the private street.

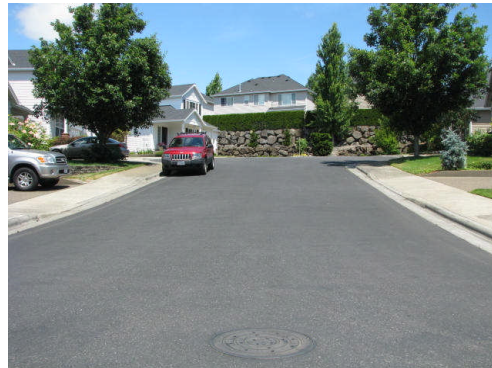
This item is the repair, maintenance or replacement of the concrete vertical curb and gutter on the private street.

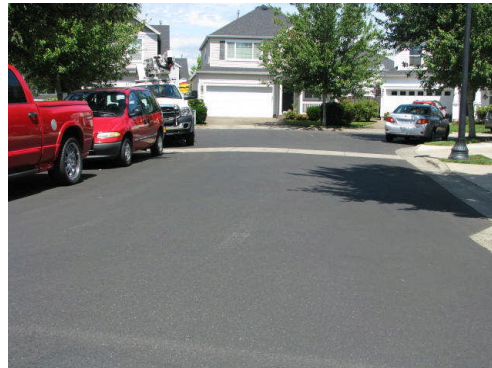
This item is the repair, maintenance or replacement of the concrete vertical curb and gutters on the private street.

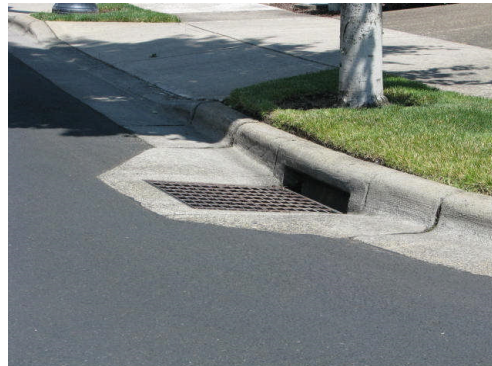
This item is an allowance for any work required on the drainage system in the community.
