Arbor Ridge P.U.D. Homeowners Association-Master

NW Laidlaw Road & NW 174th Avenue
Beaverton, Oregon 97006
July 15, 2014

Executive Summary

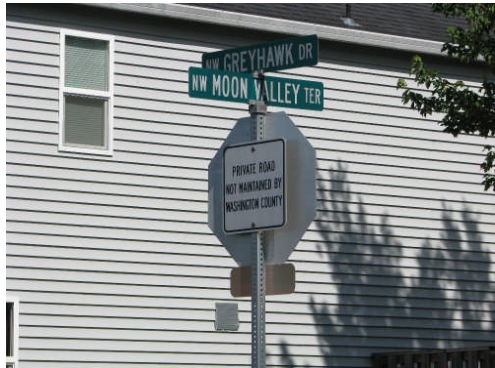
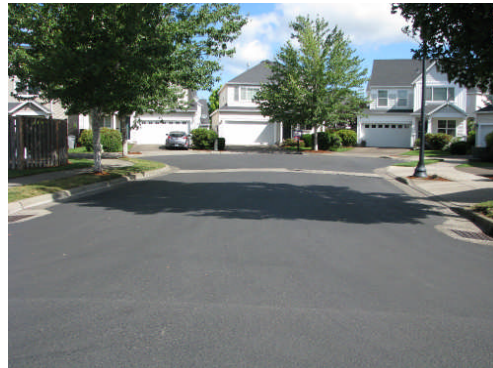
Asphalt: Overlay-Moon Valley Terrace		4,750 SF	@ \$1.20
Asset ID	1012	Asset Cost	\$5,700.00
Group	Capital	Percent Replacement	100%
Category	Moon Valley Terrace	Future Cost	\$8,111.51
Placed in Service	January 2001		
Useful Life	30		
Replacement Year	2031		
Remaining Life	15

This component is the overlay of the asphalt street serving 7 lots called Moon Valley Terrace a private street, with addresses 4302, 4316, 4321, 4328, 4333, 4340 and 4345.

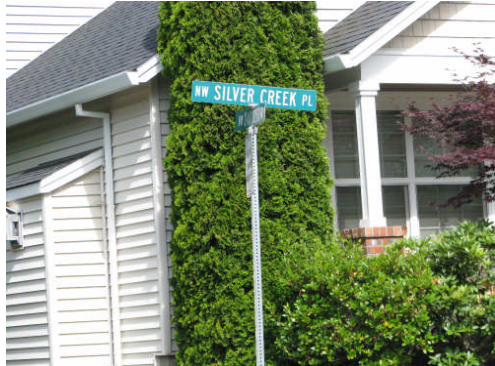
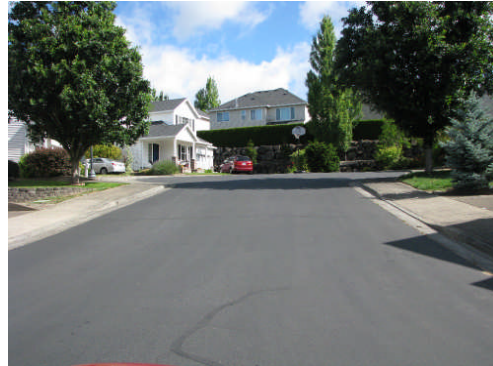
Asphalt: Overlay-Silver Creek Place		5,125 SF	@ \$1.20
Asset ID	1014	Asset Cost	\$6,150.00
Group	Capital	Percent Replacement	100%
Category	Silver Creek Place	Future Cost	\$8,751.89
Placed in Service	January 2001		
Useful Life	30		
Replacement Year	2031		
Remaining Life	15

This component is the overlay of the asphalt street serving 7 lots (Track B) called NW Silver Creek Place, 44, 45, 46, 47, 48, 49, and 50.

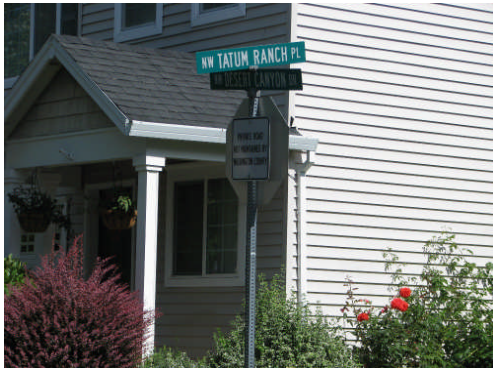
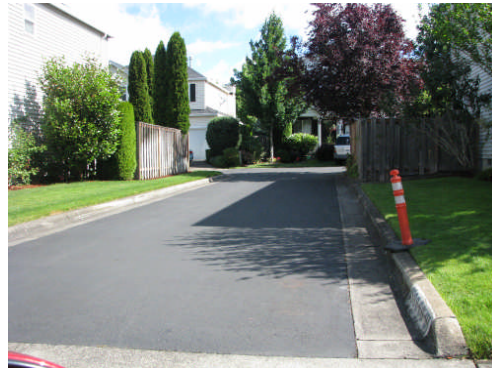
Asphalt: Overlay-Tatum Ranch Place		1,391 SF	@ \$1.20
Asset ID	1016	Asset Cost	\$1,669.20
Group	Capital	Percent Replacement	100%
Category	Tatum Ranch Place	Future Cost	\$2,375.39
Placed in Service	January 2001		
Useful Life	30		
Replacement Year	2031		
Remaining Life	15

This component is the overlay of the asphalt street serving 3 lots called Tatum Ranch Place.

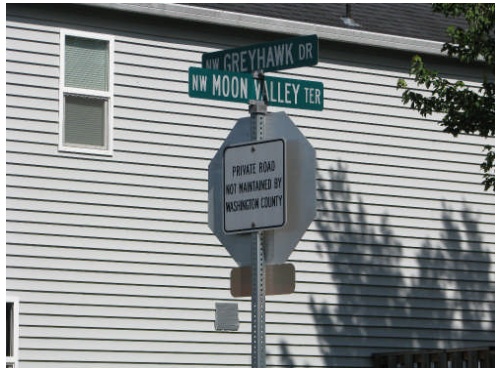
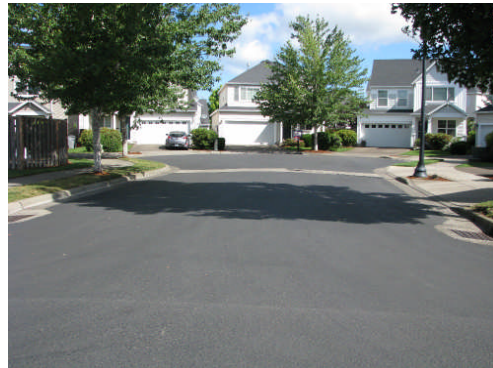
Asphalt: Repairs-Moon Valley Terrace		4,750 SF	@ \$3.75
Asset ID	1027	Asset Cost	\$536.16
Group	Capital	Percent Replacement	3.01%
Category	Moon Valley Terrace	Future Cost	\$575.36
Placed in Service	July 2014		
Useful Life	5		
Replacement Year	2019		
Remaining Life	3

This component is the repairs required on the 7 lots served by Moon Valley Terrace a private street, with addresses 4302, 4316, 4321, 4328, 4333, 4340 and 4345.

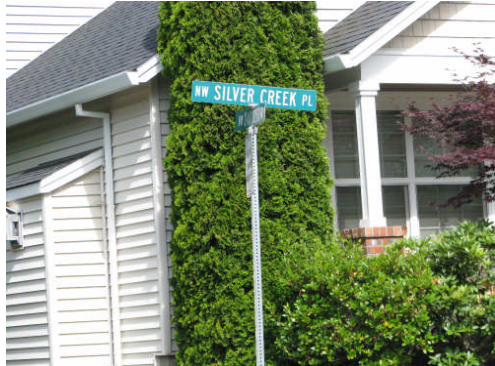
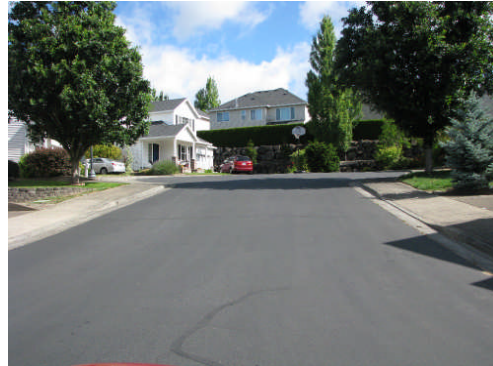
Asphalt: Repairs-Silver Creek Place		5,390 SF	@ \$3.75
Asset ID	1032	Asset Cost	\$828.71
Group	Non-Capital	Percent Replacement	4.1%
Category	Silver Creek Place	Future Cost	\$889.30
Placed in Service	January 2014		
Useful Life	5		
Replacement Year	2019		
Remaining Life	3

This component is the repairs required on the private street (Track B) called NW Silver Creek Place, serving Lots 44, 45, 46, 47, 48, 49, and 50..

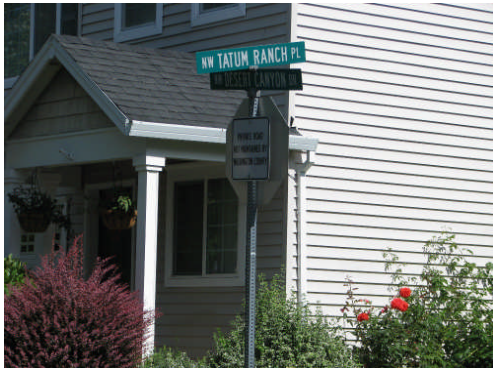
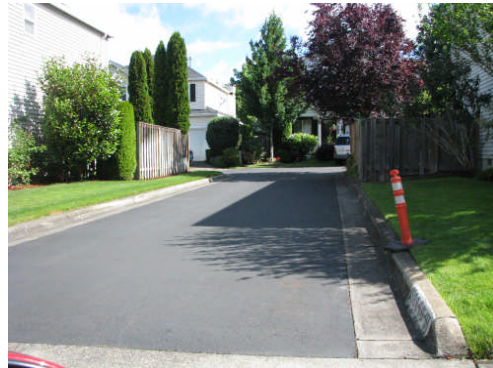
Asphalt: Repairs-Tatum Ranch Place		1,391 SF	@ \$3.75
Asset ID	1033	Asset Cost	\$185.18
Group	Capital	Percent Replacement	3.55%
Category	Tatum Ranch Place	Future Cost	\$198.72
Placed in Service	July 2014		
Useful Life	5		
Replacement Year	2019		
Remaining Life	3

This component is the repairs required on the private street.

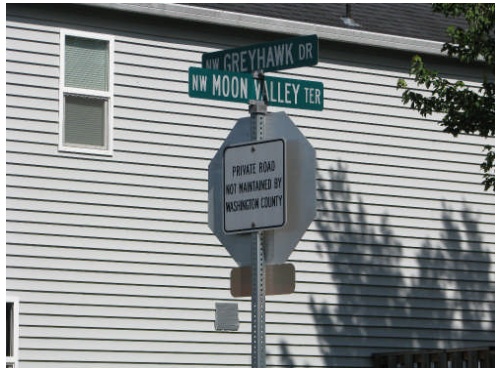
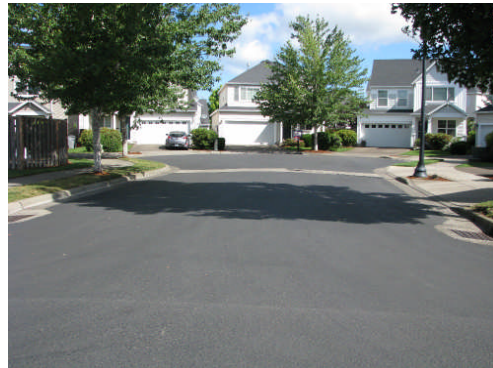
Asphalt: Sealcoat-Moon Valley Terrace		4,750 SF	@ \$0.14
Asset ID	1013	Asset Cost	\$665.00
Group	Non-Capital	Percent Replacement	100%
Category	Moon Valley Terrace	Future Cost	\$697.03
Placed in Service	September 2013		
Useful Life	5		
Replacement Year	2018		
Remaining Life	2

This component is the seal coating, and re-striping of the asphalt street serving 7 lots called Moon Valley Terrace with addresses 4302, 4316, 4321, 4328, 4333, 4340 and 4345.

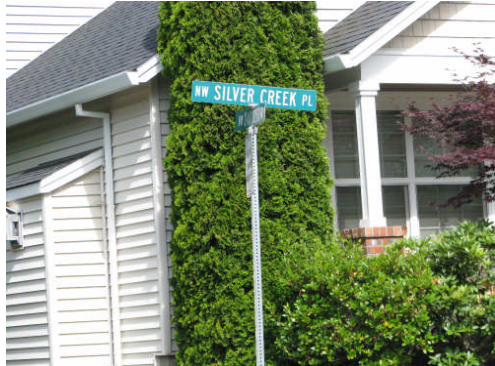
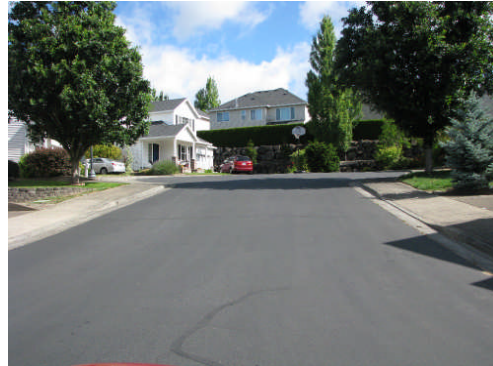
Asphalt: Sealcoat-Silver Creek Place		5,390 SF	@ \$0.14
Asset ID	1015	Asset Cost	\$754.60
Group	Non-Capital	Percent Replacement	100%
Category	Silver Creek Place	Future Cost	\$790.95
Placed in Service	September 2013		
Useful Life	5		
Replacement Year	2018		
Remaining Life	2

This component is the sealcoating, and restriping of the asphalt street serving 7 lots (Track B) called NW Silver Creek Place, 44, 45, 46, 47, 48, 49, and 50.

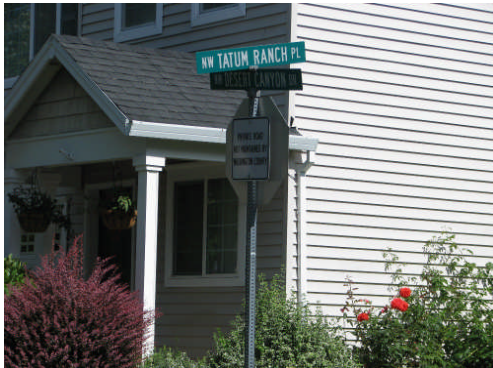
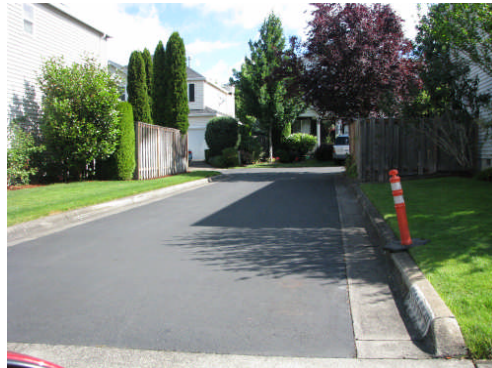
This component is the sealcoating, and re-striping of the asphalt street serving 3 lots called Tatum Ranch Place.

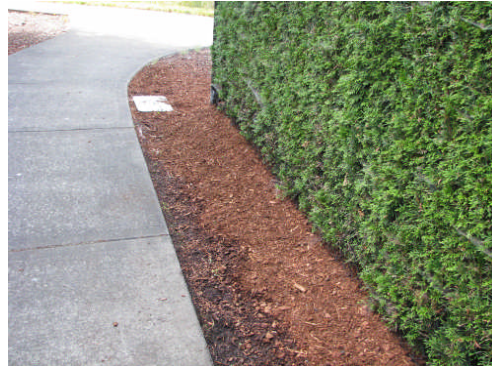
Bark Dust: Replace		25,300 SF	@ \$0.17
Asset ID	1006	Asset Cost	\$4,301.00
Group	Non-Capital	Percent Replacement	100%
Category	All Lots	Future Cost	\$4,403.36
Placed in Service	May 2015		
Useful Life	2		
Replacement Year	2017		
Remaining Life	1

This component is the bark dust spread around the landscaped beds in the common area.

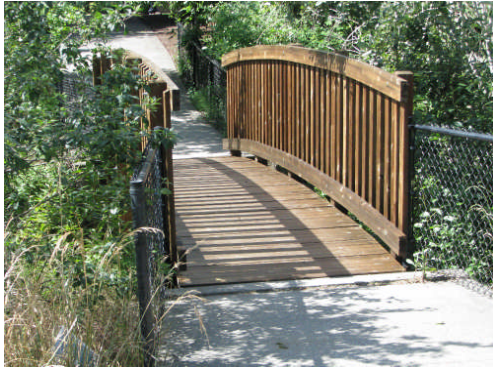
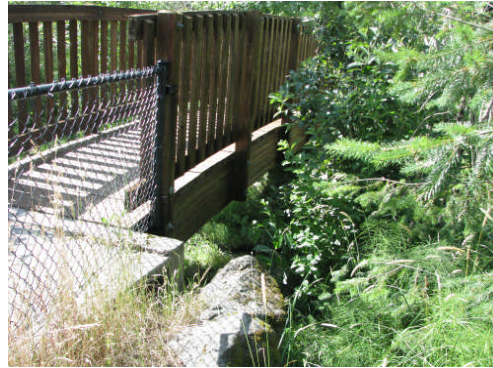
This component is the wooden pedestrian bridge over the wet lands in the common area.
